HOUSATONIC RIVER BASIN
PITTSFIELD, MASSACHUSETTS

PONTOOSUC LAKE DAM
MA 00309

PHASE 1 INSPECTION REPORT
NATIONAL DAM INSPECTION PROGRAM

JULY 1978

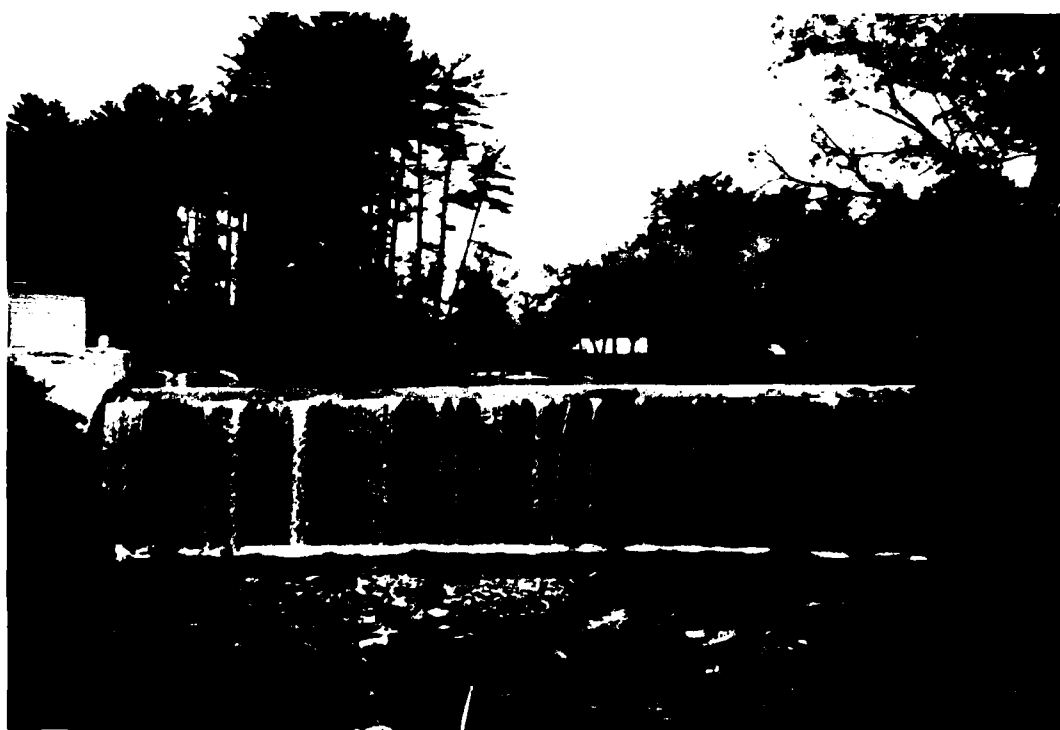
① GENERAL OVERVIEW OF MASONRY DAM AND SPILLWAY

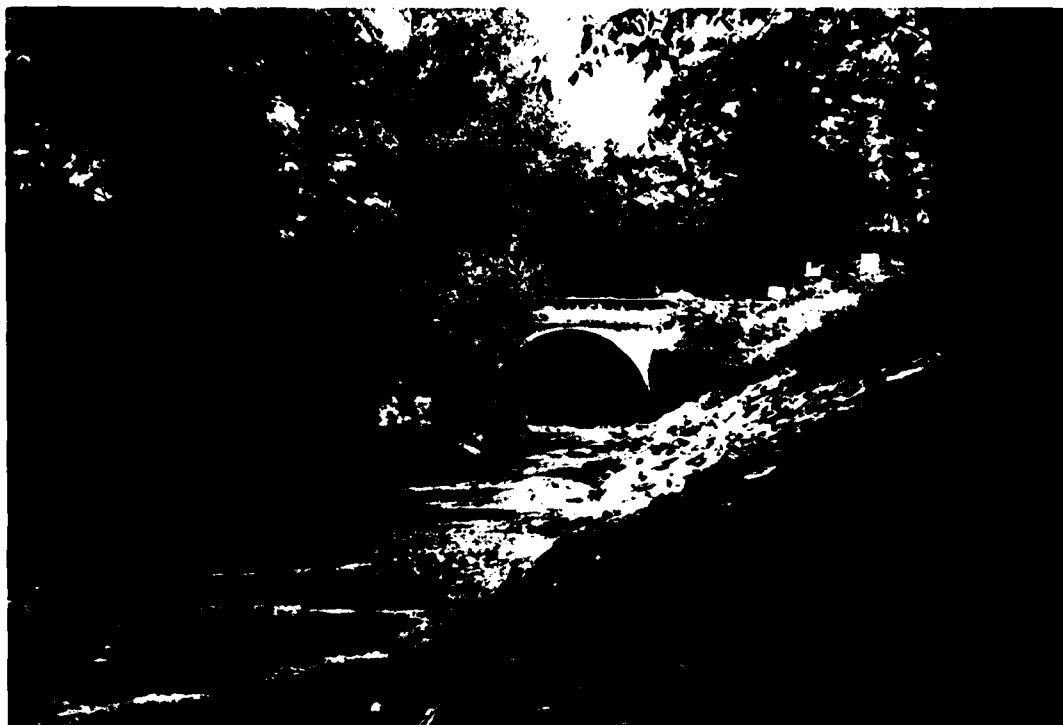
⑥ DOWNSTREAM CHANNEL WITH VIEW OF HANCOCK ROAD BRIDGE
AND CHANNEL SLOPE PROTECTION (LOOKING UPSTREAM)

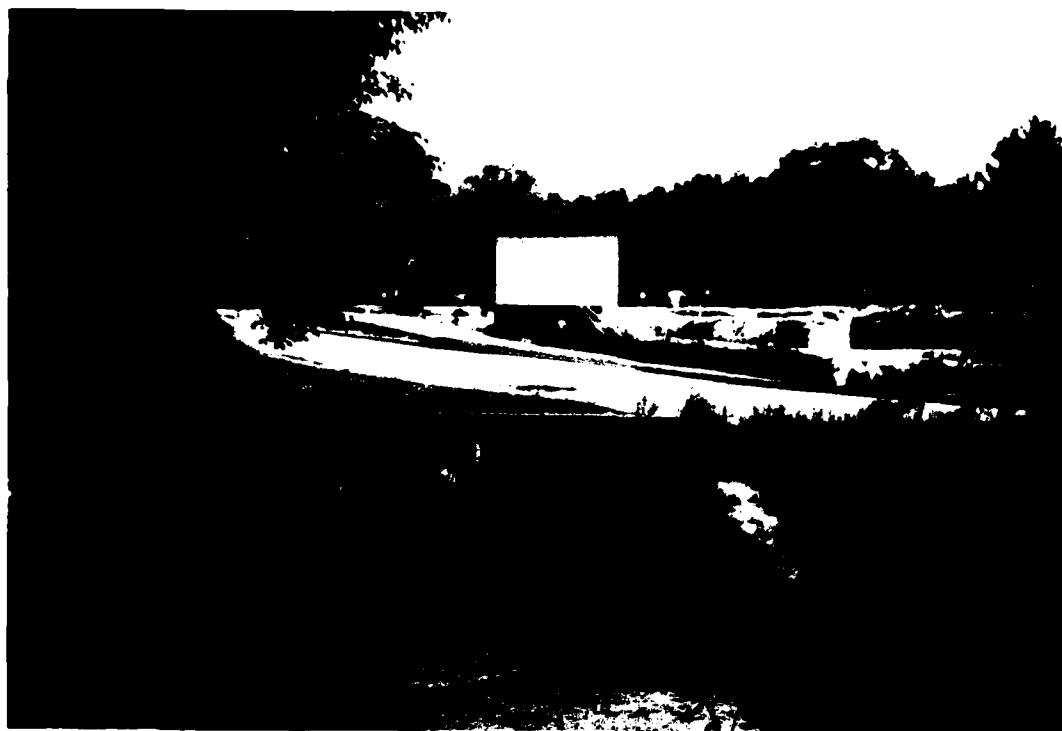
The full length of the steel flume leading from the sluiceway could not be investigated; the visible portion of the downstream end is rusty but otherwise in good condition. The concrete headwall is also in good condition with very minor spalling. The invert of the flume is filled with cobble, gravel and minor debris. (See Photograph No. 7).

⑦ VIEW OF STEEL PIPE FLUME OUTLET AND GATE HOUSE
